550SSG ROTOR AND BAIL TRIP SYSTEM – ENGINEERING IMPROVEMENT

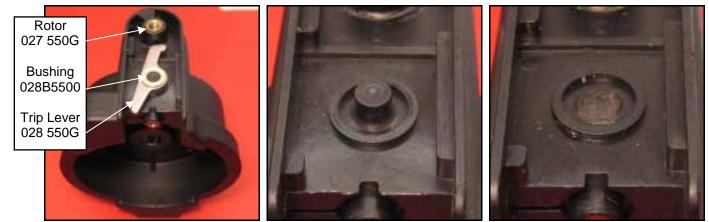
Figure A: broken 550SSG rotor

Review of reels returned by distributors and reels repaired in Penn's service department has driven a change to the 550SSG rotor and bail trip mechanism. The bail trip mechanism in SSG reels consists of a bail trip cam, a cam lever, and a trip lever. The force required to trip the bail arm and close the bail wire is transferred through the bail trip lever. Excessive bail trip force shears the post in the rotor ear, on which the bail trip lever pivots. This results in a failure of the automatic bail trip system. The diameter of the trip lever post has been increased and a washer has been added. These two changes more than double the breaking strength of the trip lever post.

In the original design of the 550SSG rotor, shown in Figure A, the trip lever 028B5500 fit on the post with a brass bushing 028B5500. Figure B shows the original design of the trip lever post. Once the post is broken, shown in Figure C, the bail trip mechanism will no long function. This requires replacement of the rotor. Reels shipped after Spring 2008 will already be of the upgraded design.

Figure B: Detail of unbroken rotor Figure C: Detail of broken rotor

Figure A shows the old parts from the broken rotor. The bushing 028B5500 and the broken rotor 027 550G can be discarded. The trip lever 028 5500 should be saved as it can be used with the new rotor. Figure D shows the new rotor 027 550G and the new washer 028B550G. The old trip lever 028 5500 can be reused in the upgraded rotor. After the release of this bulletin, any rotor 027 550G ordered will be the new design. Please contact Penn customer service for replacement parts. Once the new rotor, bail trip lever and washer are replaced, the rest of the rotor can be assembled and replaced on the reel, as usual.
